## BULLETIN No. 502

THE DRAINAGE OF IRRIGATED SHALE LAND.<sup>1</sup>

By DALTON G. MILLER, *Senior Drainage Engineer*, and L. T. JESSUP, *Junior Drainage Engineer*.

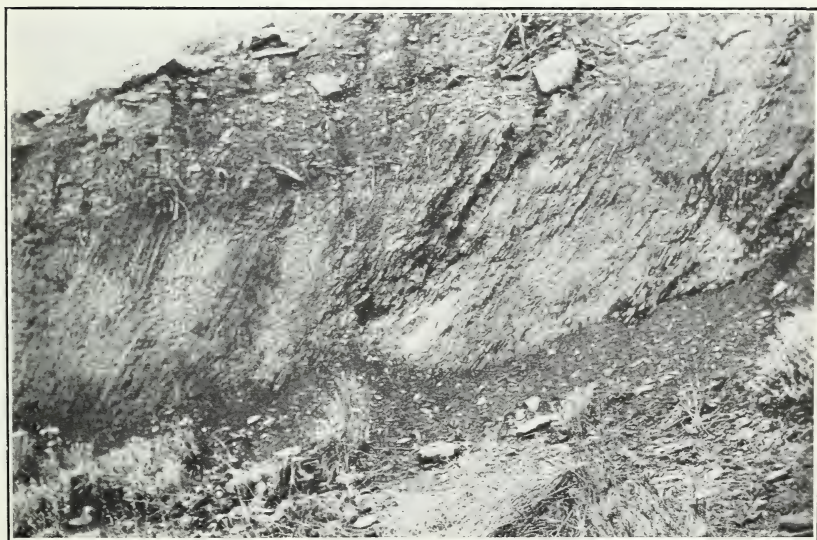
FIG. 2.

SHALE WHICH HAS BEEN UPLIFTED UNTIL THE LAYERS DIP SHARPLY.

In the second type of shale, as mentioned on page 3, the water is carried principally between the nearly vertical shale layers, as illustrated by Plate I, and the principal direction of its movement is of course parallel with the strike, especially in the deeper and less fractured zones. These water carriers have no regularity in spacing, which may vary from a small fraction of an inch to several inches. They are partly surface phenomena and diminish in number rapidly with depth and probably are better developed in the hills than in the valleys. Since the pitch of the strata usually decreases with depth, the surface of a valley cuts across a less number than does the surface of a hill.

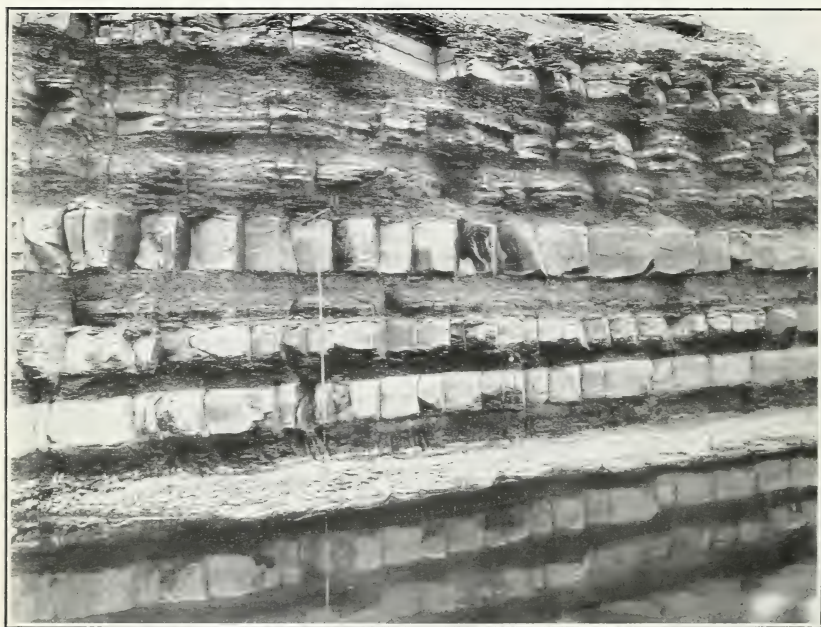
FIG. 2.—SHALES HAVING NEARLY HORIZONTAL LAYERS WHICH HAVE BEEN CUT BY CLEAVAGE PLANES CAUSED BY GREAT PRESSURE.

Cleavage planes continuous through shale layers and intervening rock strata.

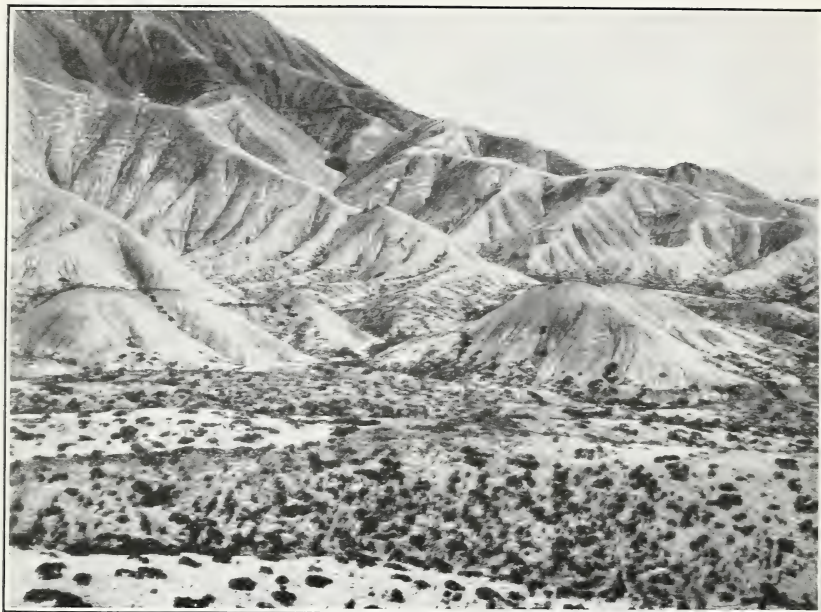
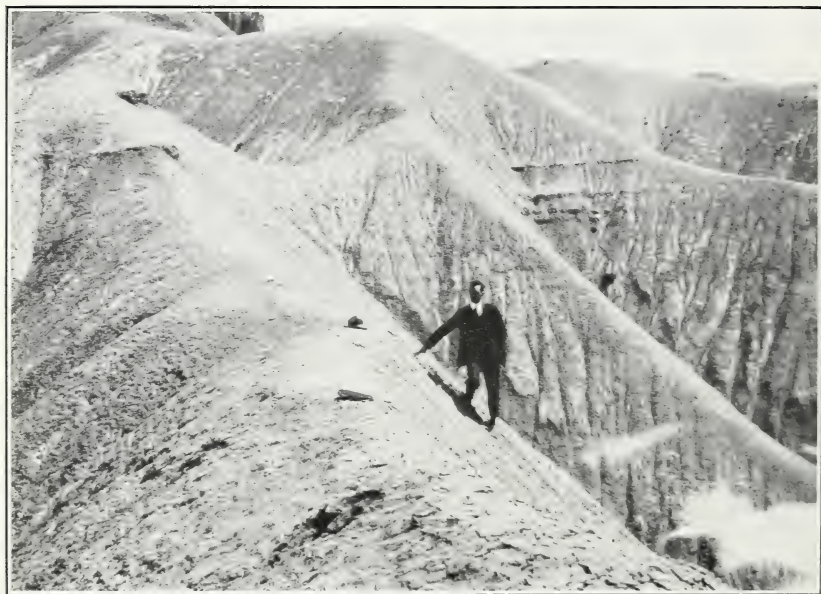
“BAD-LAND” TOPOGRAPHY, PRODUCED BY VIGOROUS EROSION  
OF THE HIGHER SLOPES.

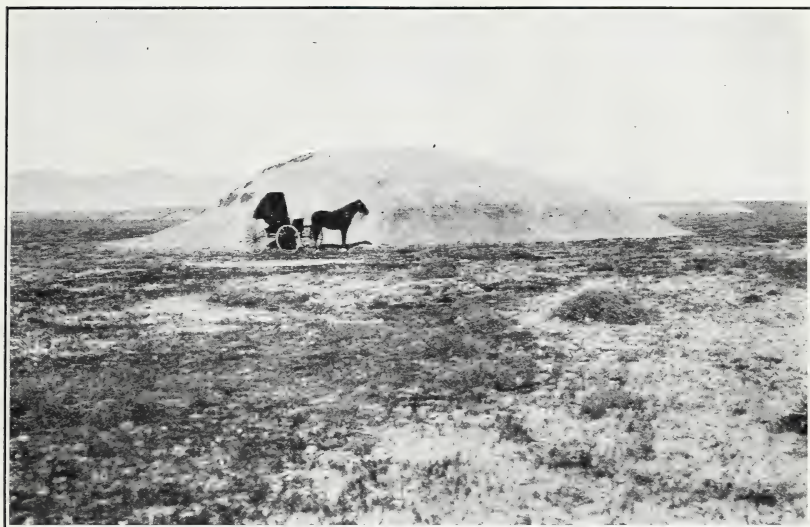
"BAD-LAND" TOPOGRAPHY. A SHALE KNOLL (FIG. 1) AND A SHALE DOME (FIG. 2).

During remote times the shale formations were subject to erosion and formed a topography of their own, similar to that of the exposed shale which can be seen at the present time. Erosion has produced "bad land" topography differing in character according to the local conditions. On the higher slopes, where erosion was especially vigorous, the shale is cut by deep, V-shaped ravines, the sides of which are very steep or nearly vertical (Pl. IV). Sometimes knolls or domes occur, as illustrated by Plate V. The bottoms of the

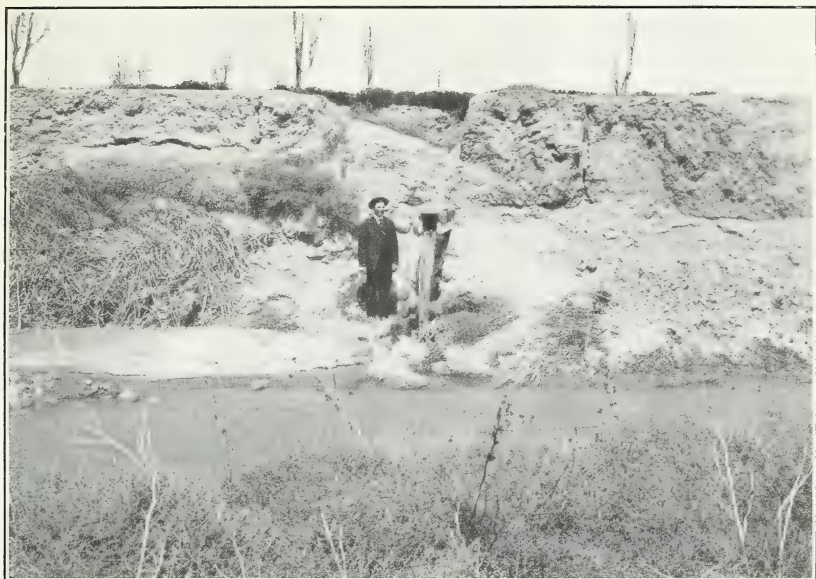
FIG. 1.—OUTLET OF DRAIN, SHOWING QUANTITY OF WATER DEVELOPED.
